## POSITION PAPER 3

### THE CASE FOR THE MANDATORY FITTING OF RESIDUAL PRESSURE VALVES TO GAS CYLINDERS CONTAINING CARBON DIOXIDE

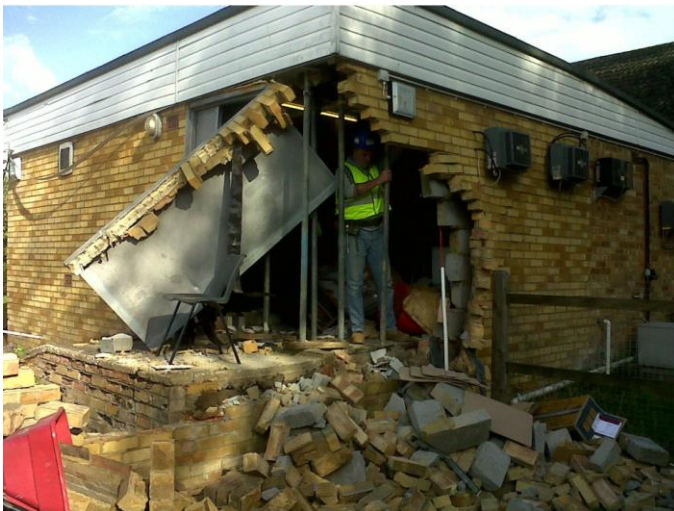
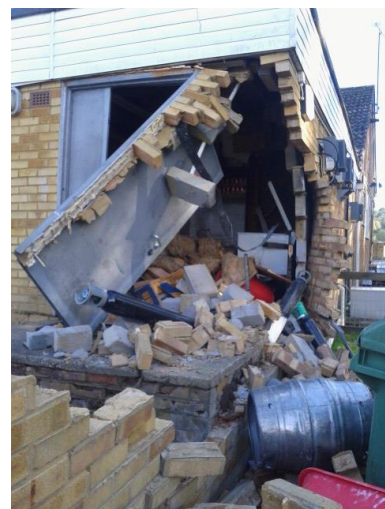
### Marlow RFC

A gas cylinder used to dispense beer exploded in a storage room at Marlow Rugby Football Club in the morning of 12 October 2012. The cylinder was filled with a carbon dioxide 30 % / nitrogen 70 % mixture. The HSE investigated and discovered that the cylinder was badly corroded and that the RPV was missing (presumed removed). The failure mechanism was identified as stress corrosion cracking due to aqueous contamination. The cylinder explosion partly demolished the building.

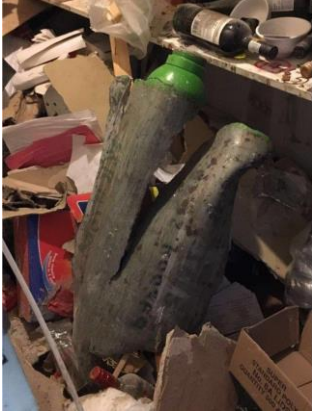
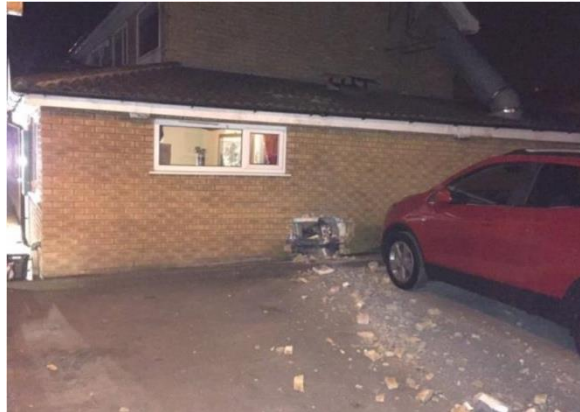
### **Lancashire Chinese restaurant**

In May 2016 an explosion occurred in a Chinese restaurant, leaving a hole in the wall and blowing out all the windows. Restaurant closed for the evening so no injuries. Caused extensive damage internally. The cylinder made its own exit via the wall, leaving debris over the adjacent road. The cylinder was a carbon dioxide / nitrogen mixture.
